Shared Maintenance Offering: Troubleshooting

Original Instructions

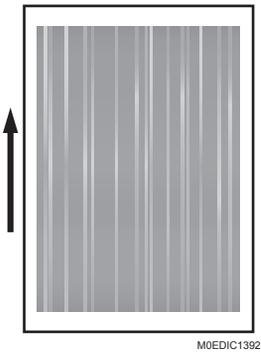
White streaks in the paper feed direction on a pure black halftone image printed on the 2nd side of a duplexed page.

Cause:

Uneven temperature on the media surface due to uneven contact between the media and cooling belts, which affects the image transfer.

1. Open the right front cover of the left unit, and then lower the lever for A5/Half Letter to the right.

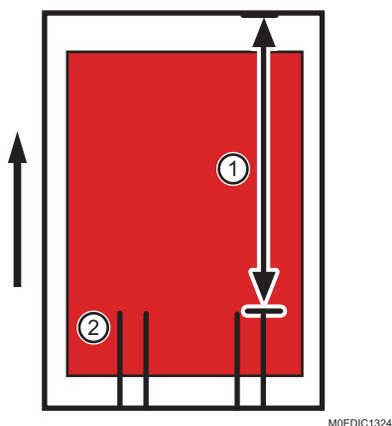
Multiple black streaks in the paper feed direction around the trailing edge.

1. 308 mm (12.1 inches) from leading edge
2. Streaks

- Occurs in low temperature / low humidity environments.
- Likely to occur with solid images containing two colors. For example, red and green.
- The streaks appear in both image and non-image areas.
- The drag-mark-like streaks are often in black, but may also be in cyan.
- The streaks appear approximately 310 mm (12.2 inches) from the leading edge.

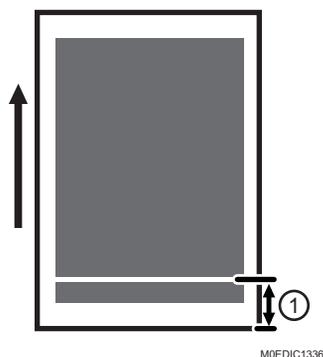
When using thick paper, white streaks appear in the area 20 to 22 mm (0.8 to 0.9 inches) from the trailing edge of the paper.

1. 21 mm (0.8 inches)

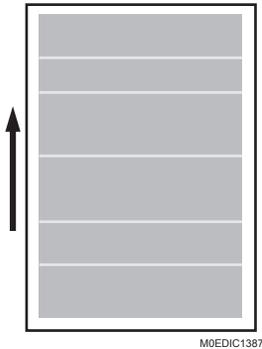
Synthetic (waterproof) paper tends to be charged and have a streak in low coverage images.

Synthetic (waterproof) paper tends to be charged, which makes the paper repel toner and causes a streak in low coverage images.

- Synthetic / waterproof paper
- Mostly in halftone images
- Depending on the state of paper charge, the problem may not repeat in the same conditions.

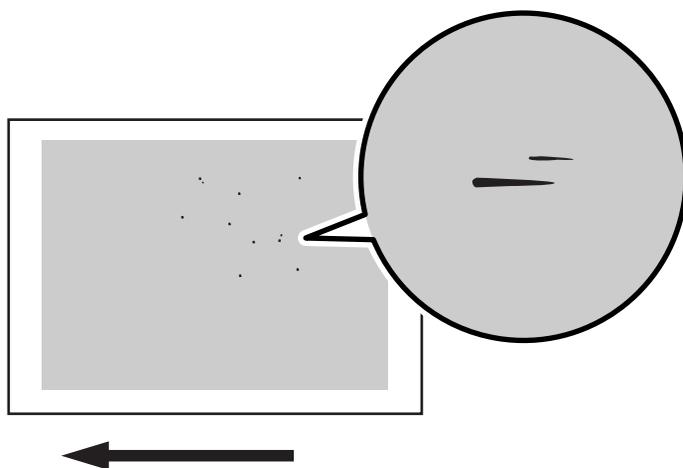
CEZ538

Paper is stained with toner spots of 0.5–1 mm (0.02–0.04 inches) in diameter.

The amount of toner that the cleaning web fails to pick up differs depending on the image data, paper feed mode, and paper type so the symptoms also differ.

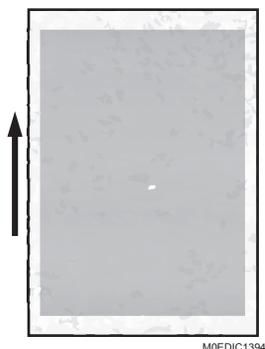
MOEDIC1394

Color spots appear on rugged surfaces when using uneven paper.

- The air in the indentations was compressed and flowed to the upstream side of the paper feed direction when the intermediate transfer belt contacts the indentations of uneven paper. Then the toner on the upstream side of the paper feed direction is pushed to the downstream side by the compressed air. When the force which pushes the toner is larger than the electrostatic sticking force of the toner, the toner is flipped, and color spots appear.
- This may occur when textured paper is used in an environment with high temperature and humidity.

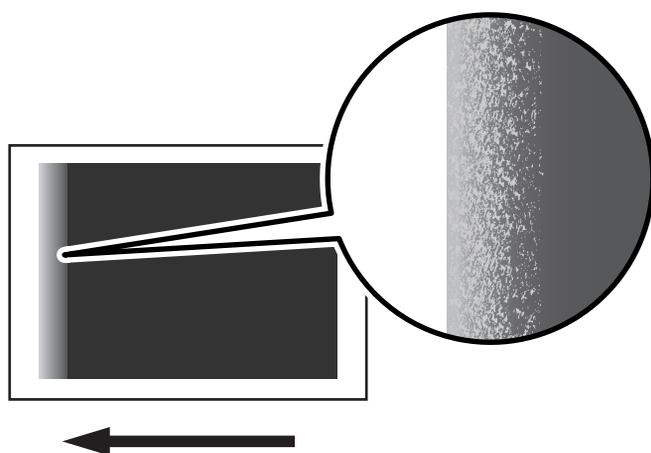
CEZ562

Image quality degradation within 30 mm from the leading or trailing edge of the paper (Excessive or Insufficient Density / Horizontal Streaks / White Spots / Stains / Toner Scattering / Faint)

Inadequate transfer current setting.

1. In [Detailed settings] for custom paper, in 1217: [Paper Transfer Output Correction: Paper Edge], adjust the length of the area to apply correction at the leading edge of paper in 02: [Leading Edge Length] and 07: [Leading Edge Length] according to the range of image quality degradation.

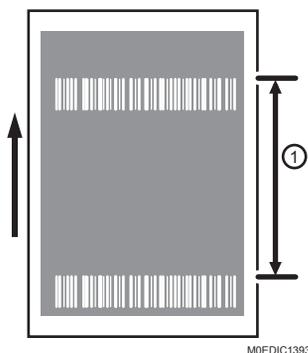
When printing an image with half-tone parts, white spots appear at intervals of 310 mm (12.2 inches) in the paper feed direction.

1. 310 mm (12.2 inches)

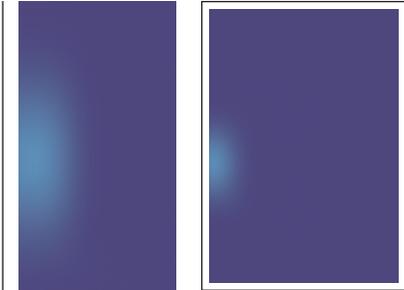
MOEDIC1334

Oval white spots appear at the positions of the paper feed tray's fans (at the leading, trailing, and side edges of paper).

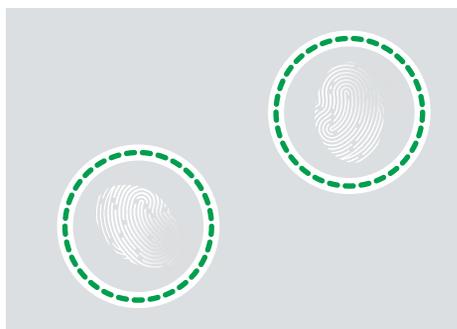
MOEDIC1354

Fingerprints stick on paper, which changes the electrical resistance of the paper and the quality of image transfer changes, causing white spots.

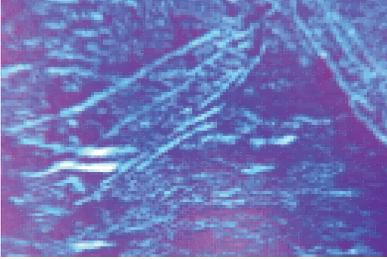
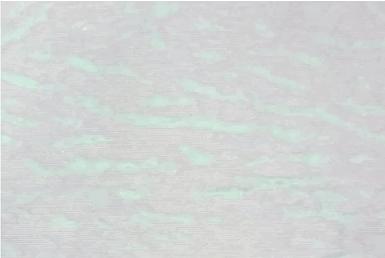
White Spots on Indentations:

Excessive Density on Indentations:

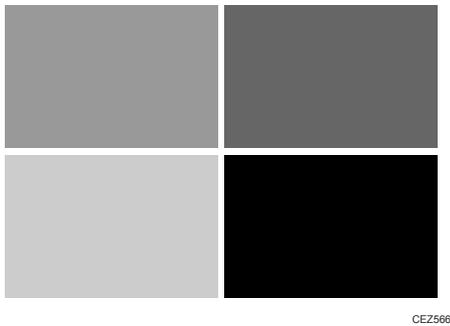
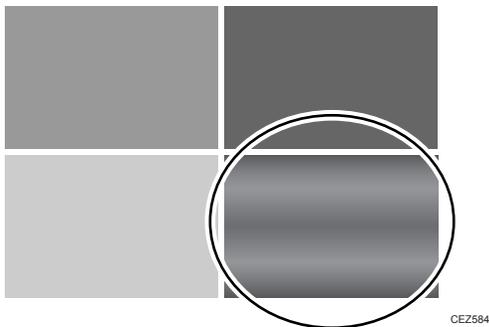
Abnormal image

- Excessive transfer when printing in full color.
- Mismatch between the calibration and measured ID.
- Insufficient transferability due to mottling.

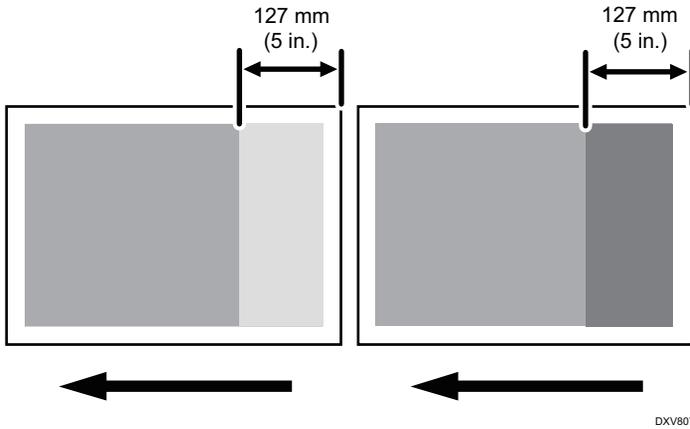
Printing in the area extending approximately 127 mm (5 inches) from the trailing edge is fainter or denser.

When the paper passes the Transfer Timing Roller, in the pre-nip area before the paper transfer unit, the sticking force and the distance between the intermediate transfer belt and paper differ, which causes density unevenness.

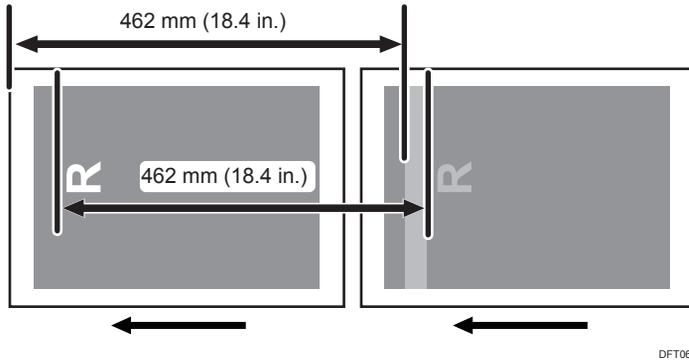
A ghost image of a printed image appears at a distance of 462 mm (18.4 inches) to the side of the image.

- Printing solid fills
- At the start of the paper transfer

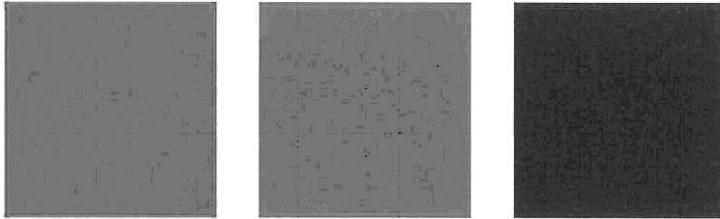
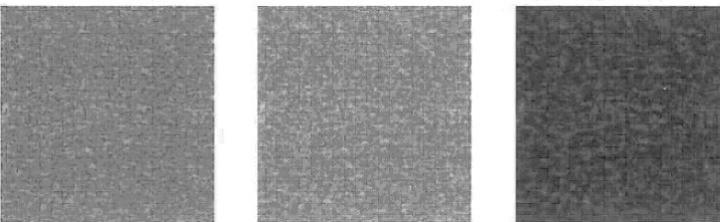
Mottled

- Using paper with low smoothness or low friction
- Print coverage is low (consecutively printing with low toner density)

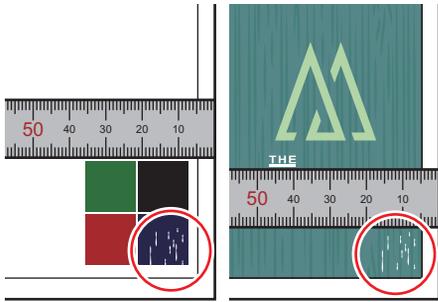
MOEDIC1395

Due to the temperature condition of thin paper, the paper transport is affected, causing the trailing edge of paper to curl upward and come into contact with the fusing belt at the fusing unit entrance, resulting in white spots.

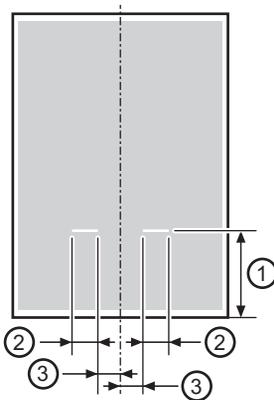
MOEDIC1357

White spots with a width of approximately 15 mm (0.6 inches) appear at the area 35 mm to 45 mm (1.4- 1.6 inches) away from the center of the paper.

1. 120 mm (4.7 inches)
2. 15 mm (0.6 inches)
3. 35–40 mm (1.4- 1.6 inches)

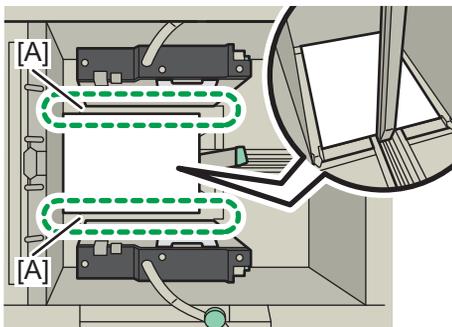
M0EDIC1366

There is a gap (A) between the side fences and the paper, so the paper fed is skewed towards the paper feed direction.

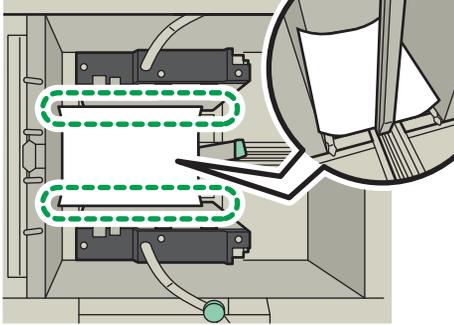
D0EDIC1367

The side fences are positioned too narrowly.

The side fences are positioned too narrowly so that the paper is arched, causing the paper's resistance to be lifted at the front edge, resulting in paper misfeeds.

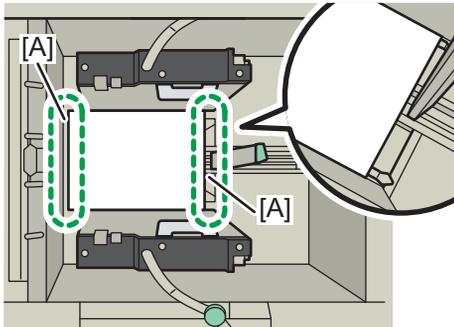
M0EDIC1369

The gap (A) between the end fence and paper, and the gap between the faceplate and paper add up to 3 mm (0.1 inches) or more. The paper is misaligned backward, causing double feeding.

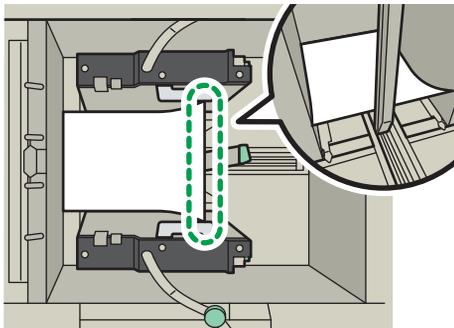
M0EDIC1370

The end fences are positioned too narrowly.

The end fence is positioned too narrowly so that the paper is arched, causing the paper's resistance to be lifted at the front edge which results in paper misfeeds.

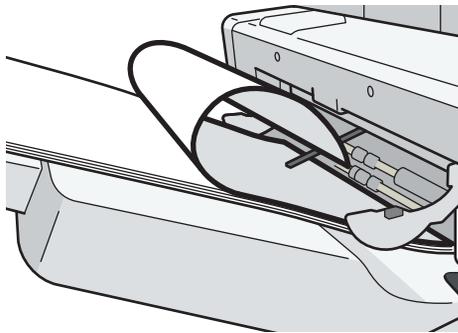
MOEDIC1356

A3 or larger paper with a thickness of Paper Weight 1 (cross-grain direction) or Paper Weight 2 (grain direction) are delivered with a face-up curl (approximately 15 mm (0.6 inches)), resulting in the leading edge of the paper riding up and rolling upward.

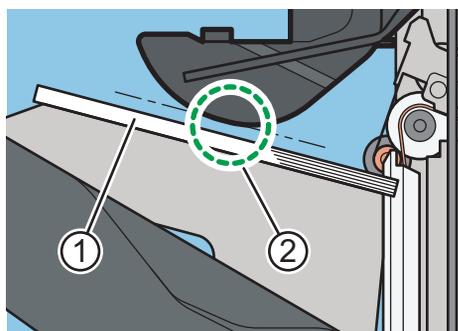
The width alignment cannot be performed with the Z-fold support tray attached

2. Jogger cannot reach the paper surface

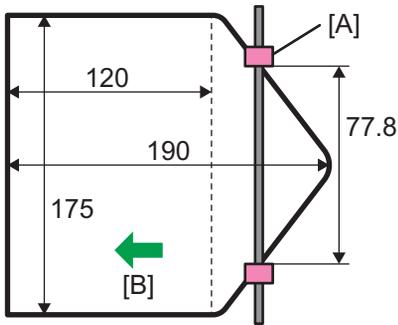
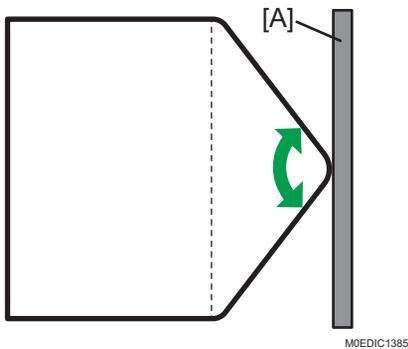
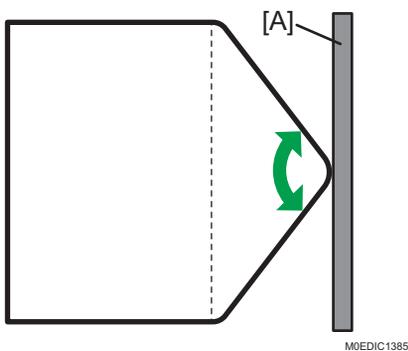
1. The trailing edge of the envelope is delivered by the paper exit roller to the exit tray, but the center of the flap at the trailing edge is still prone to remain in the machine when the envelope has passed the paper exit roller's nip.

- The center of the flap is humped, so the envelope fails to be flush against the end fence.

- The flap is thinner than other parts of the envelope, so the height of the tray is prone to be higher than the paper exit roller as more envelopes are stacked. The angle of paper delivery becomes steep, resulting in increased resistance, and failure to deliver the envelope.

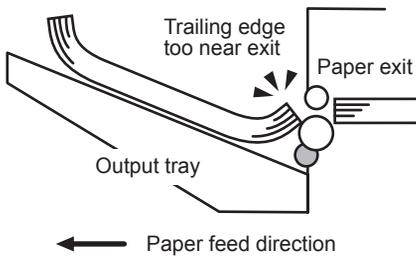
If the stapled sheets are curled strongly or become limp after delivery, the trailing edge of the sheets may be too close to the paper exit when the paper is stacked.

If this happens, stapled sheets, when delivered, may push the previously delivered sheet, resulting in paper bending or misfeeding.

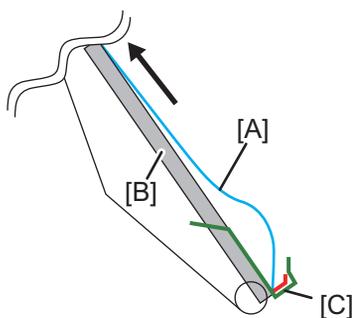
MOEDIC1361

In the binding process, when thin, coated paper [A] is discharged from the staple tray [B], as the staple tray that pushes and lifts up the trailing edge of the paper is at a steep angle (55°), it results in a difference in linear speed between the leading edge and trailing edge, making it buckle; the release pawl [C] is unable to lift it up, resulting in scratches on the paper and/or jams.

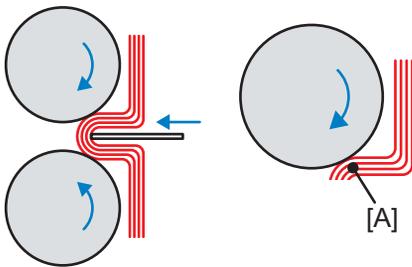
MOEDIC1379

However, the friction between the sheets (A) is weak for paper with high image density, such as those with solid fills, resulting in reduced power to deliver sheets other than the front cover. Consequently, paper slip occurs with the delivery of only the front cover while other sheets remain in the booklet tray, causing a paper jam (JAM618 or JAM641).

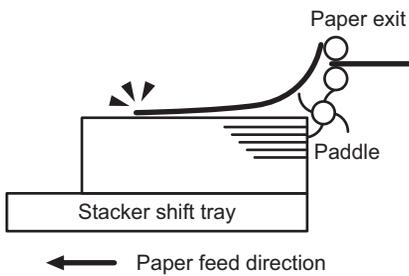
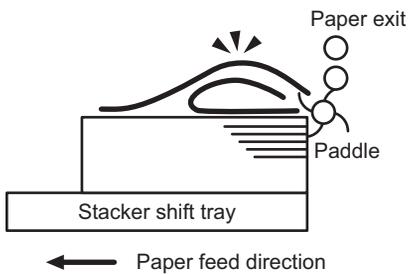
With sheets that are curled downward and sheets that are not curled, the leading edge of the sheet being delivered rubs against the top sheet of the stack, there being no air gap between the sheets, and the sheet being delivered is therefore prone to get stuck. Consequently, the trailing edge of the sheet being delivered is left in the paper exit, and the next sheet to be delivered slips under the sheet still in the paper exit and bends back.

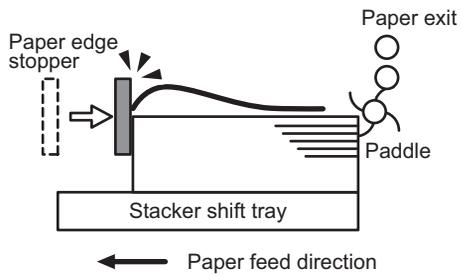
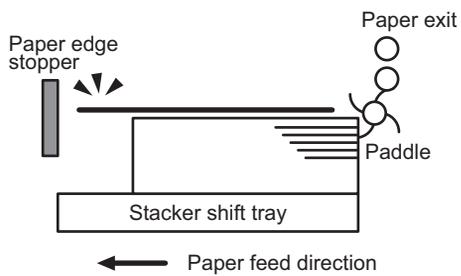
The trailing edge of the sheets delivered to the stacker tray are aligned by the paddle. If the delivered sheets are flat, the friction at the trailing edge increases and affects the alignment of the sheets parallel to the paper feed direction. Also, when the leading edge stopper stops the leading edge of paper, the paper may be stopped with the leading edge protruding, resulting in horizontal misalignment when stacked.

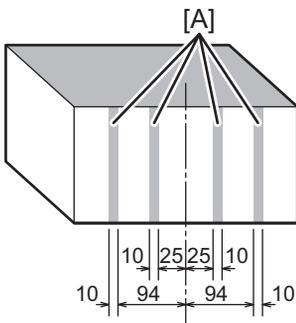
MOEDIC1364

The leading edge of paper is stained [A] for a width of 10 mm (0.4 inches) at the area 25 mm (0.1 inches) and 94 mm (3.7 inches) away from its center.
